## Videx 3171 Digital

# WIRING DIAGRAM

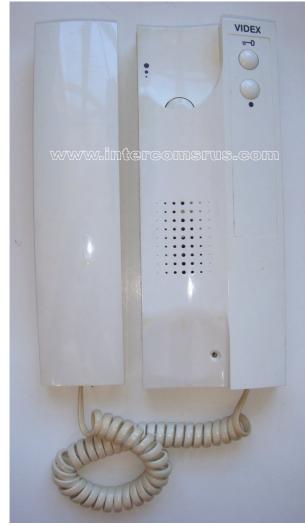
### Terminals (2 Wire)

- L Data Line
- Common
- LB Local Bell
- AL Alarm Switched 0v
- SW Aux Switch
- SW Aux Switch

Set Dip Switches as per original (this is the address of the handset) Binary numbering 1 2 3 4 5 6 7 8 Dip switch number

1 2 4 8 16 32 64 128 Binary Number Example (flat 12) 3 & 4 ON rest OFF

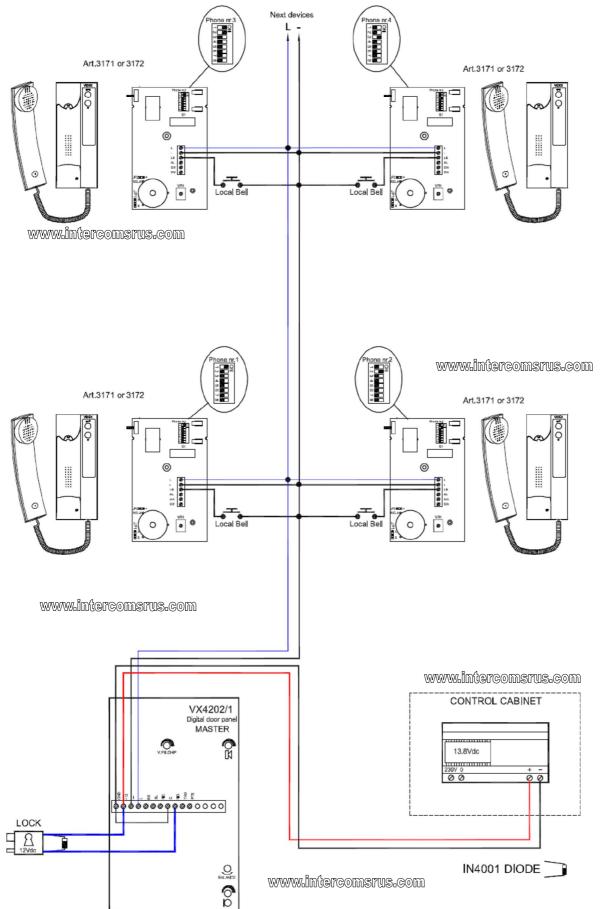
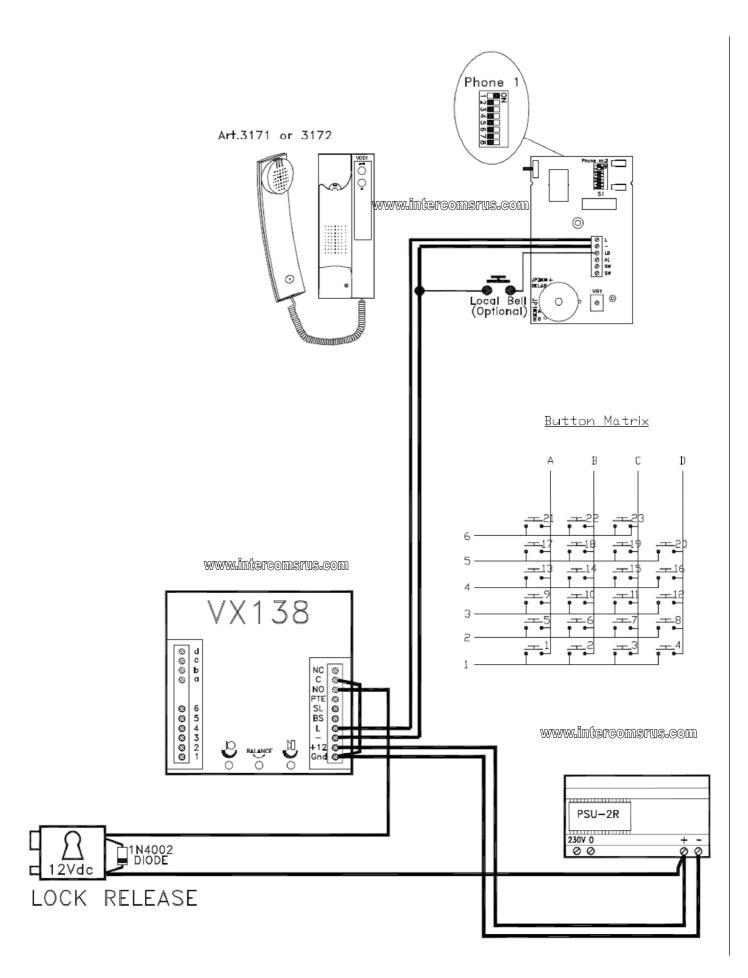
1) Before replacing the handset make note of the wires to each terminal on the existing unit (an easy way is to cut each core off leaving a piece of the insulation in place with colour visible) twist unused cores together (so you know they are not used, do not short them out).

2) Some older systems will have cable with one coloured core and a solid white core in this case mark each core with a marker or tape.

3) Some systems may have loop on wiring, you will have 2 cables into your handset (make sure any joins remain, as these may be serving other flats on the system).
